# Manhole Inspection Summary

Manhole # S27I\_\_008MH

Insp Date: **5/30/08 9:15 AM**

**Location** Address: **884 W Lombard st**

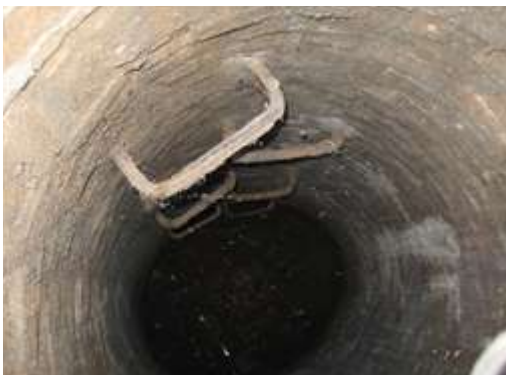
Defect 7

Count: **6** Missing: **0** ☒ **Corroded**

corroded rungs

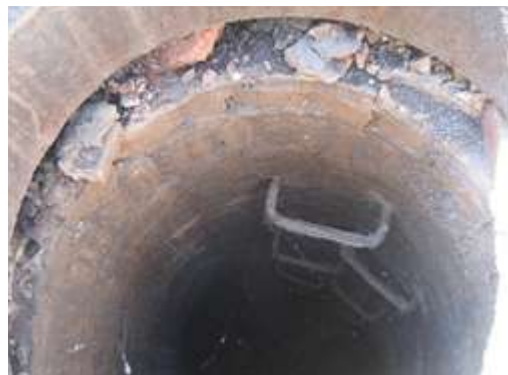
Defect 1

Condition: ☐ Sound ☐ Cracked ☐ Root Intrusion ☒ **Loose Brick** ☒ **Deteriorated**

Infiltration: ☐ None ☒ **Joint** ☐ Cracks ☒ **Mortar** ☐ Roots ☐ Wall

Missing bricks & mortar, infiltration from joint frame-chimney as well as lid frame

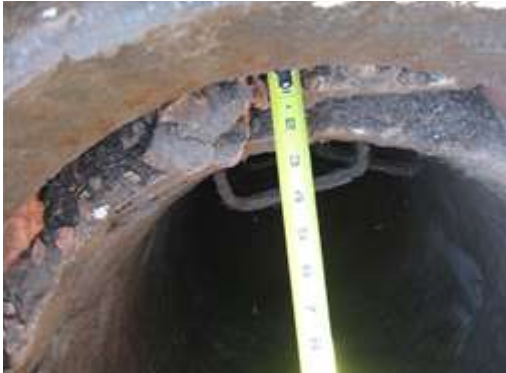
Defect 6

Offset: **2.5** (in.)

2.5 frame offset

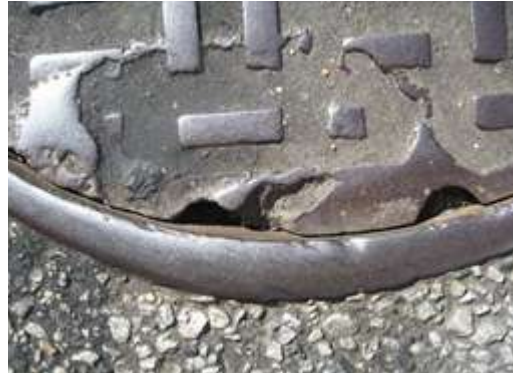
Defect 5

Condition: **Worn**

cover - missing pieces

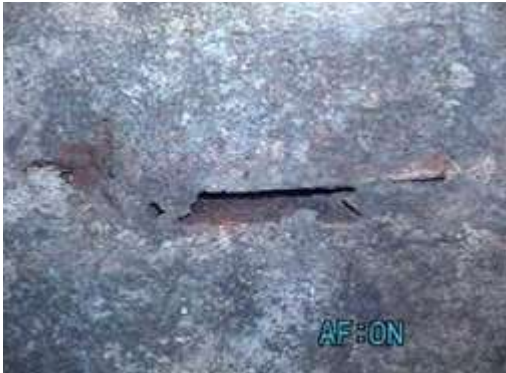
Defect 4

Infiltration: ☐ None ☐ Joint ☐ Cracks ☒ **Mortar** ☐ Roots ☐ Wall

infiltration barrel missing mortar

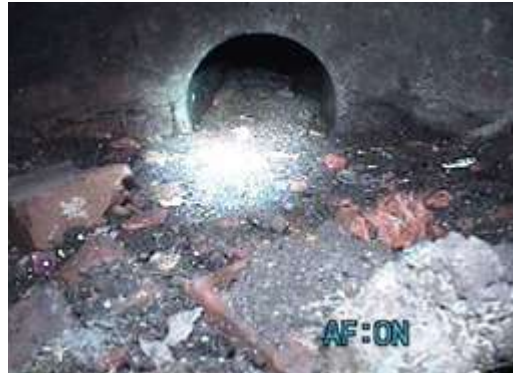
Defect 3

Condition: ☐ Sound ☐ Cracked ☐ Root Intrusion ☐ Deteriorated ☐ Leaks ☒ **Debris**

debris in channel

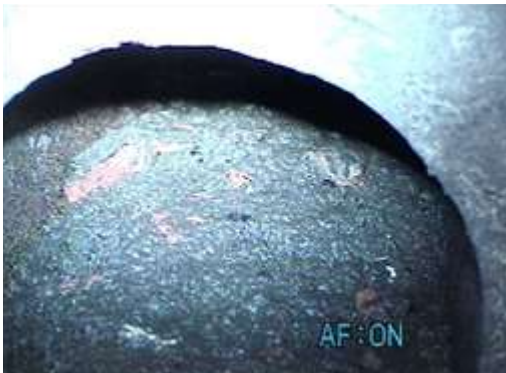
Defect 2

debris in pipe

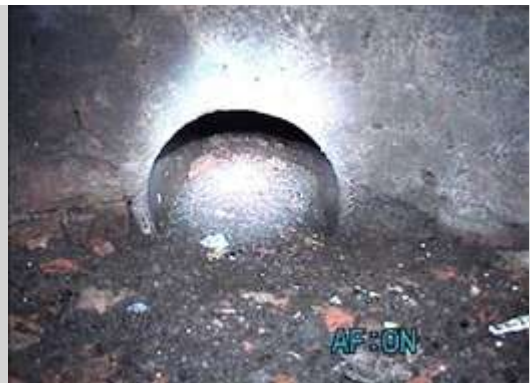
12 O'Clock Outflow

Deposits: ☐ None ☒ **Mud** ☐ Sludge ☒ **Debris** ☐ Grease

Silt Depth: **3** (in.) Deposits Extent: **Medium**
